## Understanding Substantial Damage in the International Building Code, International Existing Building Code, or International Residential Code

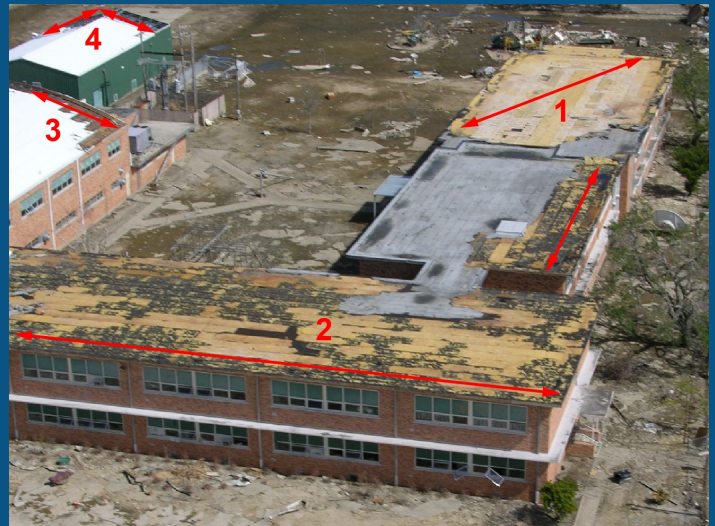
Figure 4. View of damaged school. Four buildings are numbered. Red arrows indicate areas where the roof membrane (Buildings 1-3) or metal roof panels (Building 4) blew off.

- The four school buildings each sustained damage from high winds during a hurricane. A significant amount of the roof membrane was blown off Buildings 1 and 2. Building 4 lost some of the metal roof panels. Only Building 3 had a secondary roof membrane; it sustained little rainwater penetration into the building when part of the roof covering was blown off. For Buildings 1 and 2, the rainwater penetrated into the interiors and damage was more extensive. Buildings 1 and 2 also sustained collapse of several of the acoustical ceiling boards on the second floor and a few on the first floor. Most of the interior gypsum board partitions on the second floor of Buildings 1 and 2 were damaged by rainwater. Rooftop equipment was blown off Building 1, and a few Building 1 exterior windows were broken by wind-borne debris. Wind-driven rain entered at several of the operable windows in Buildings 1 and 2.
